The Latest SAV Mapping and Interpretation and Trends

Sarah H. Fernald

Research Coordinator, NYSDEC HRNERR

Hudson River Estuary Submerged Aquatic Vegetation Maps

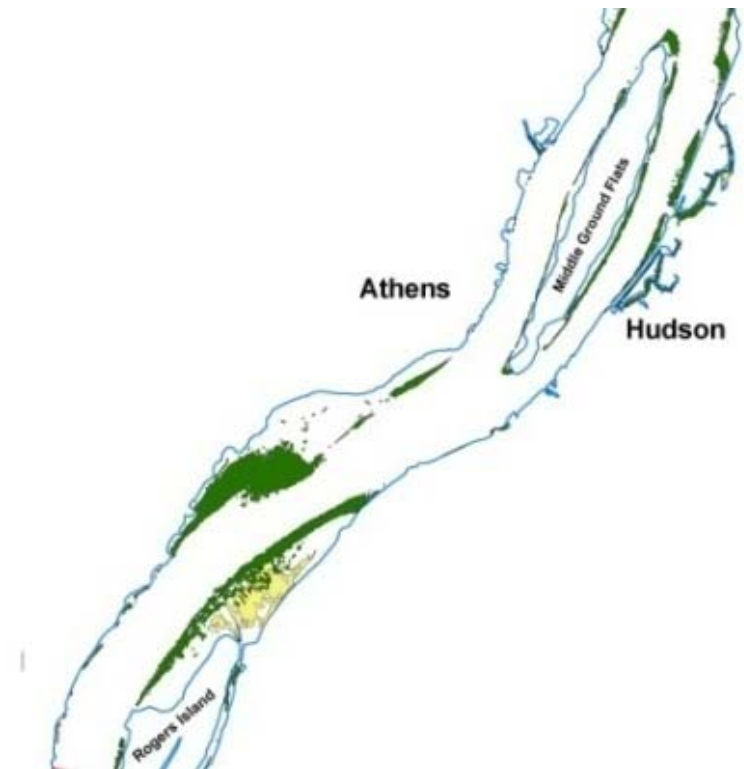
SAV Mapping Products

Hastings-on-Hudson to the Troy Dam

- 1) Submerged Aquatic Vegetation 1997
- 2) Submerged Aquatic Vegetation 2002
- 3) Submerged Aquatic Vegetation 2007
- 4) Documented SAV (1997 2002 2007)

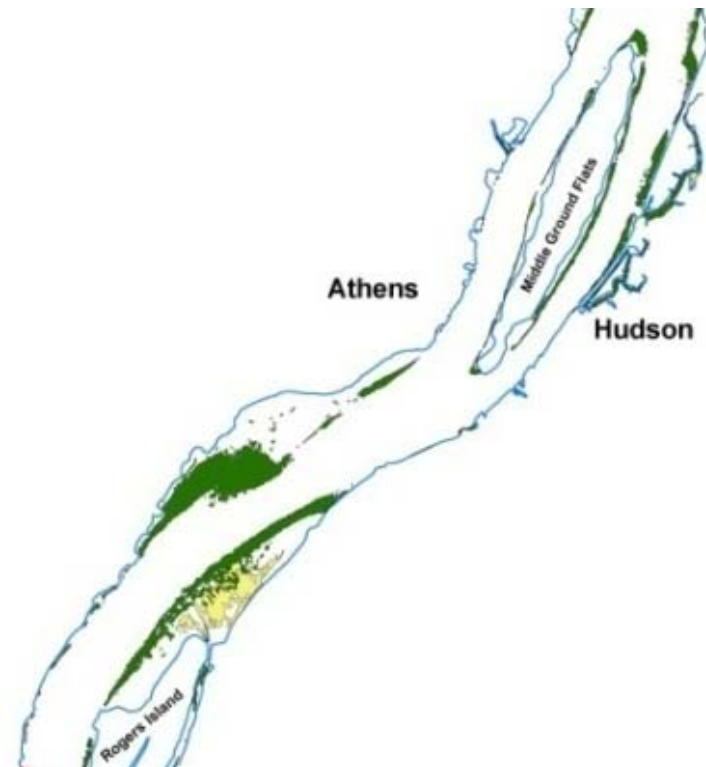
SAV Mapping Products

Hastings-on-Hudson to the Troy Dam

- 1) Submerged Aquatic Vegetation 1997
- 2) Submerged Aquatic Vegetation 2002
- 3) Submerged Aquatic Vegetation 2007
- 4) Documented SAV (1997 2002 2007)

- 5) Submerged Aquatic Vegetation 2014
- 6) Documented SAV (1997 2002 2007 2014)

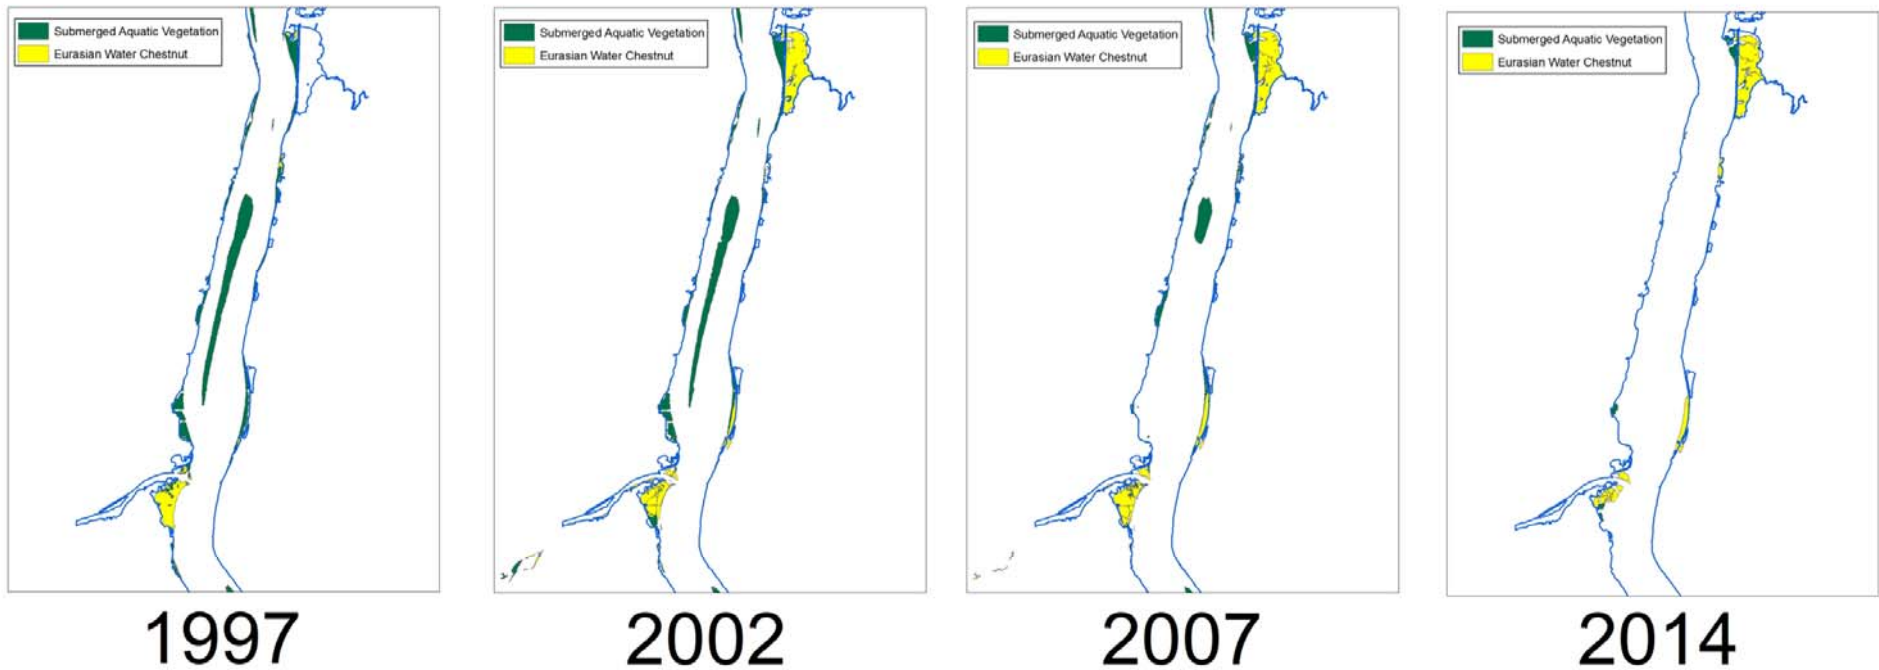
12/2/2016 **Kingston-Rhinecliff Bridge SAV bed change comparison 1997-2014**

Lost SAV...

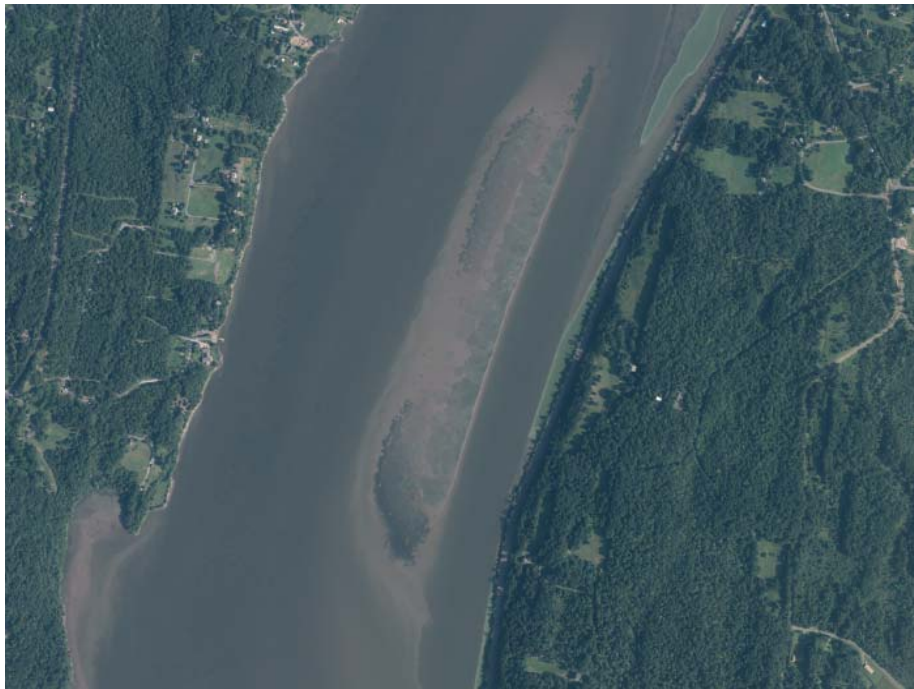
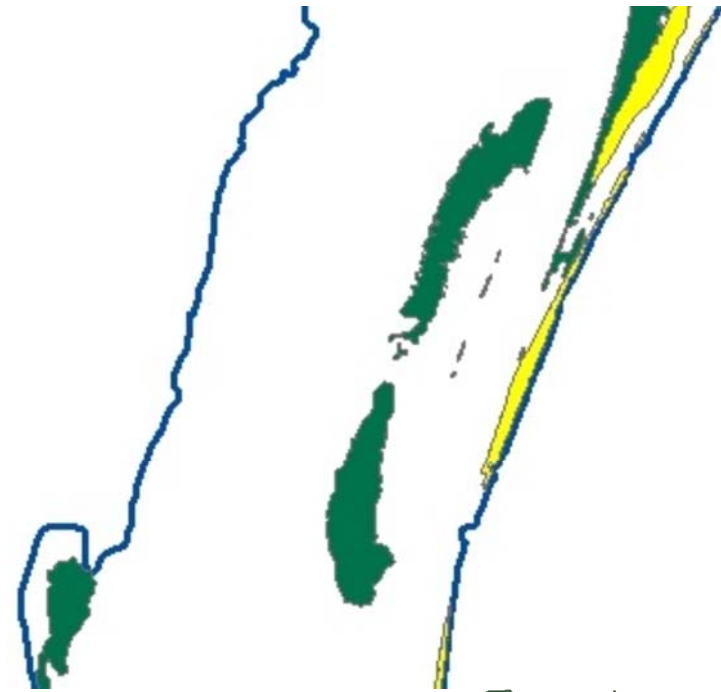
12/2/2018 **Upper Flats / Cheviot 2014**

Low Density SAV...

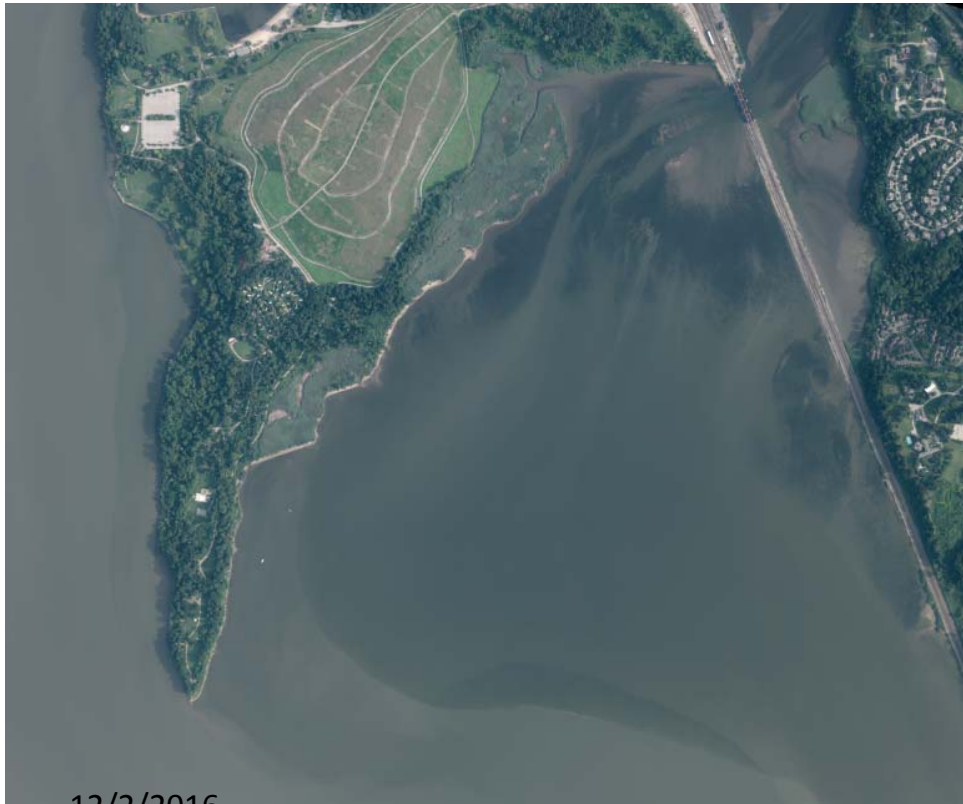
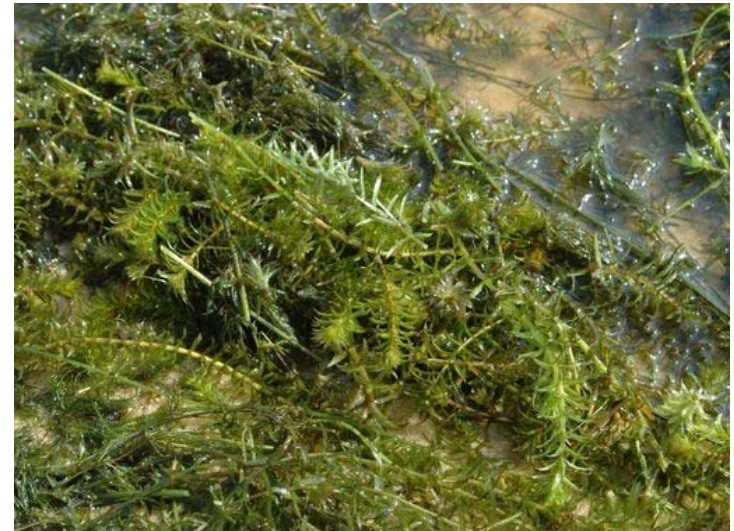
2014 Aerial Photos: Croton Point

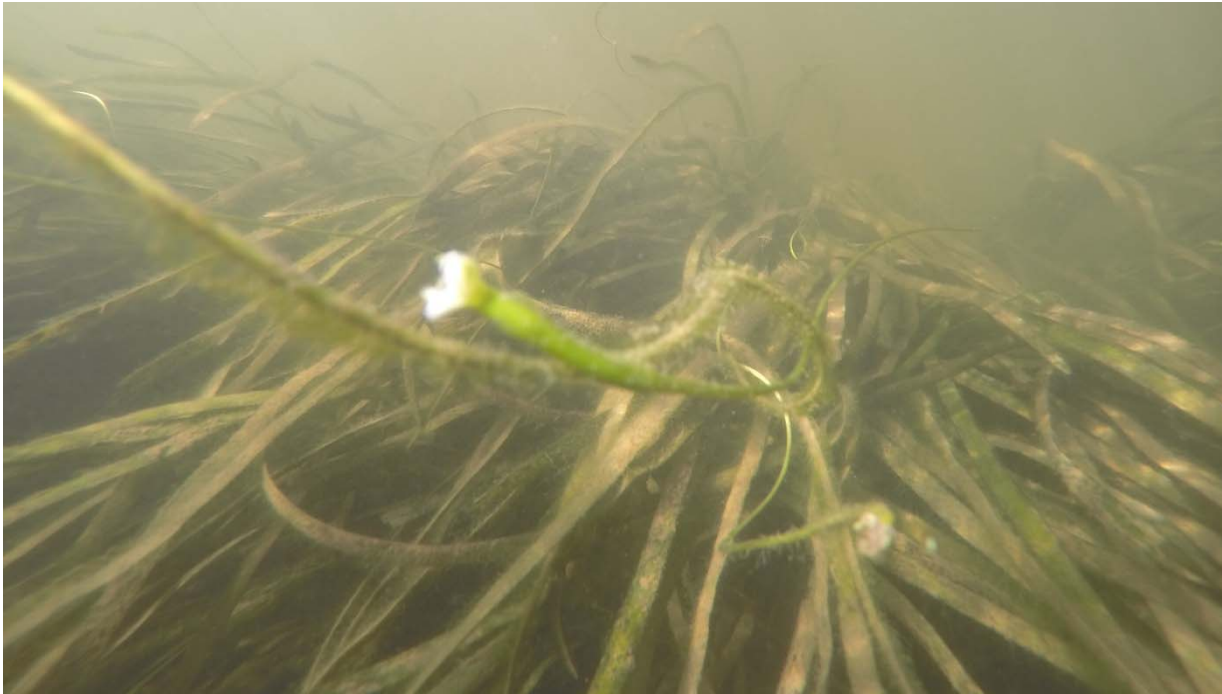
2016 SAV Aerial Photo Inventory

SAV bed south of Cruger Island/Tivoli Bays
