CASE STUDY: ATHENS FOURTH STREET KAYAK & CANOE LAUNCH

OVERVIEW

An eroding and littered shoreline was cleaned up and repurposed to provide greater recreational access to the riverfront. Major accomplishments of the project included aesthetic enhancements, parking lot expansion, shoreline stabilization, and installation of a pier, accessible ramp, and floating launch.

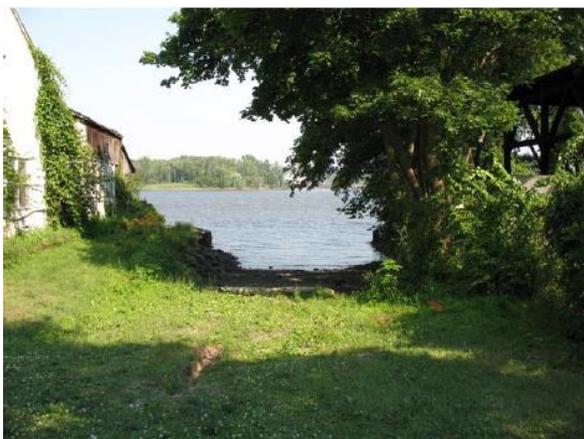
Figure 1: Prior to the project, the unimproved boat launch was overgrown and difficult to access.

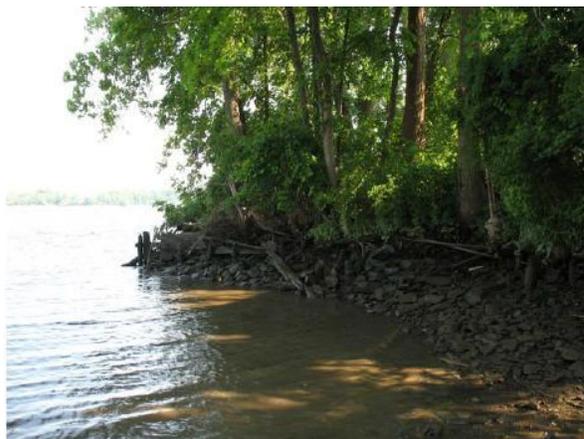
Figure 2: Shoreline was previously protected with rip-rap and degraded pilings on the southwest shore.

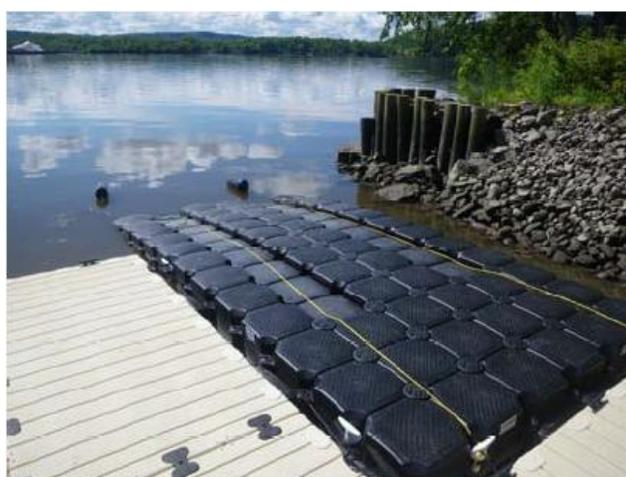
Figure 4: Floating dock with shoreline rip rap and pilings visible in the background.

Timber pilings were placed in front of the degrading piles at the cove entrance. The wood pilings serve a dual purpose: they provide shelter and habitat for aquatic life, while also protecting the corners of the cove from ice and wave action. (See figure 4.) The existing rip rap on the sloping sides of the cove was reinforced with new rock. The rip-rap absorbs wave energy and thus protects the shore from erosion. Vegetation which has grown-in on the rip-rapped south slope provides additional protection and habitat. (See below in figures 6-8.) Vertical shoreline protection was kept to a minimum. An elevated wood pier supported by pilings was installed over the rip-rapped north edge, allowing pedestrian access while maintaining the sloped bank. Trees and shrubs adjacent to the pedestrian pier and elsewhere provide aesthetic enhancement. Collectively, these improvements protect the riverbank from erosion while enhancing its ecology.

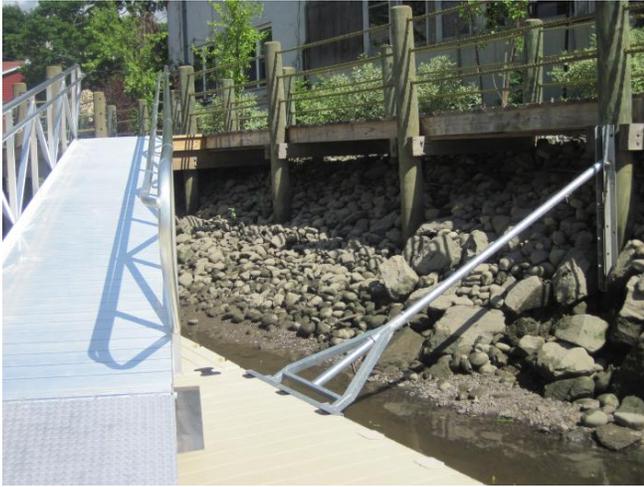
Figure 5: Ramp leading to floating dock allows access. The elevated walkway allows for a sloped shoreline and protective rip-rap to be maintained underneath.

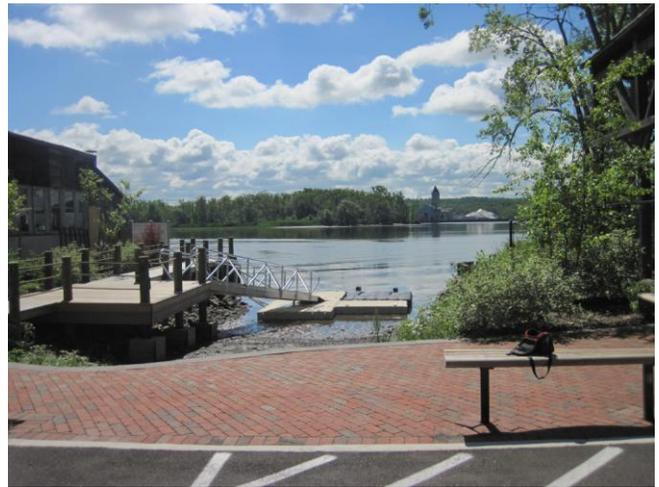
Figure 6: Completed pedestrian walkway, pier, and floating dock in summer 2010.

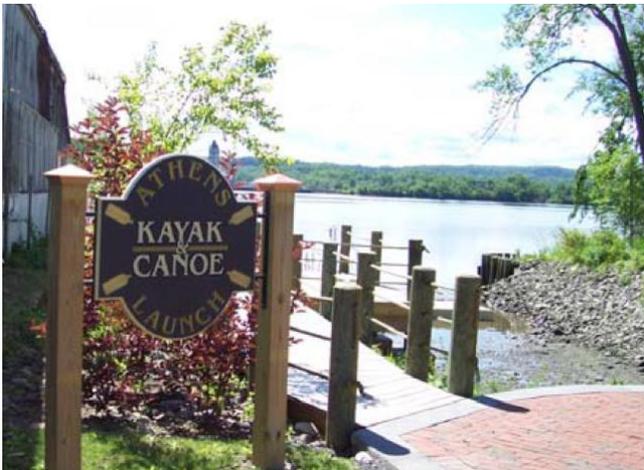
Figure 7: Kayak and Canoe Launch entryway in 2010. Reinforced rip-rap protects the southwest shore and provides vegetation an opportunity to grow.

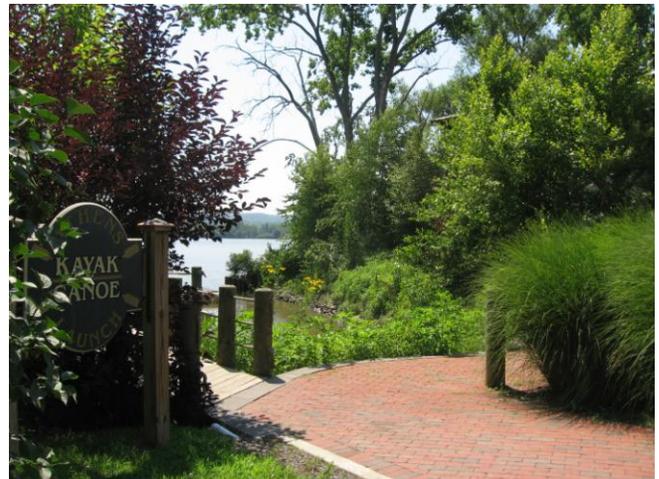
Figure 8: By summer 2013, native vegetation such as dogwood, chokeberry, bayberry, serviceberry, and birch are well-established around the cove, particularly along the southwest slope. Species diversity and limited maintenance can improve an area's ecological value.
