## CASE STUDY: ESOPUS MEADOWS PRESERVE & WATER TRAIL SITE

An existing degraded building, shoreline armoring, and impervious surfaces were removed and replaced with an erosion resistant shoreline that has natural features which have improved habitat and recreational access.

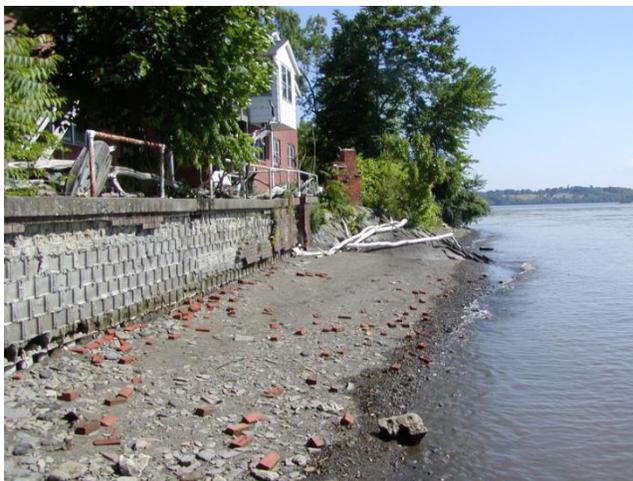
Figure 1: Previous bulkhead and house in 2002.

Scenic Hudson acquired the parcel adjacent to Esopus Meadows tidal flats in 1996, and in 2003, the organization sought to create a water trail stop for non-motorized boat users to access the Esopus Meadows property. At the time, the existing shoreline consisted of a brick building protected by a failing bulkhead that was damaging shoreline habitats, interrupting sediment processes, and limiting access for paddlers. Scenic Hudson sought to remove these impediments to human access and restore natural shoreline attributes.

In order to make the shoreline as natural as possible, Scenic Hudson proposed to remove the degrading bulkhead, as well as the nearby building, and stabilize the shore with softer alternatives that would still provide shoreline protection. In addition to making the area more ecologically enhanced and aesthetically pleasing, Scenic Hudson also sought a design that would enable paddlers to easily stop and enjoy the site. Esopus Meadows is now one of many stops along the Hudson River Greenway Water Trail.

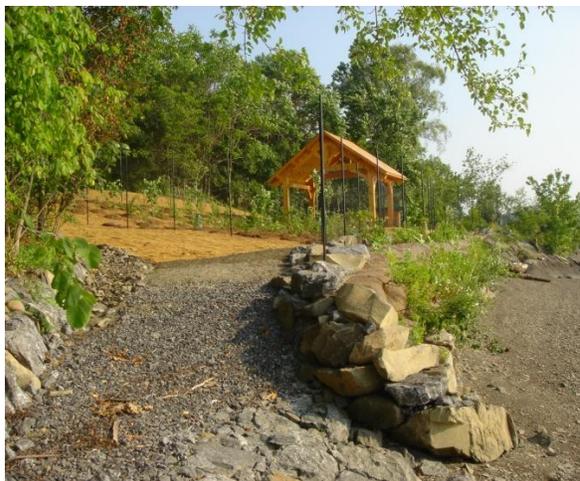
Figure 2: Boat launch and new embankment nearly complete in August 2006.

In 2006, demolition of the bulkhead and deteriorating building began, followed by re-grading and installation of the stone toe and soft gabions and planting of the shrubs. The stone toe was placed at the high tide level for spring tides, which occur at the new and full moon. Soft gabions use a geotextile to wrap soil and rock, in order to rebuild and stabilize the slope. In this case, the geotextile was an erosion control mat of woven bristle coir which is made from coconut husks. This completely biodegradable material is wildlife friendly as it does not ensnare animals such as snakes, birds, and fish. A mixture of native shrub species was planted between the soft gabions. These included dogwood, chokeberry, American elderberry, and arrowwood. These species, in particular, were selected because of their resistance to beaver and muskrat - two common herbivores in the area. Using a variety of different species reduces the risk for a complete die off or dieback of vegetation due to natural forces, animals, human disturbances, or disease. The project was completed in September 2006. Approximately 125 feet of hard shoreline was replaced with a more natural shoreline.

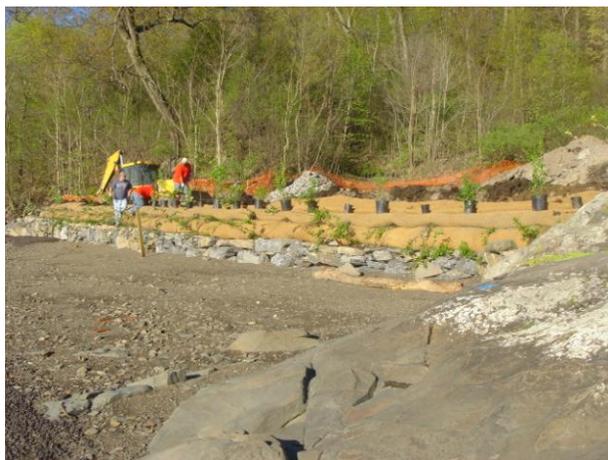
Figure 3: Soft gabions installed in May 2006.

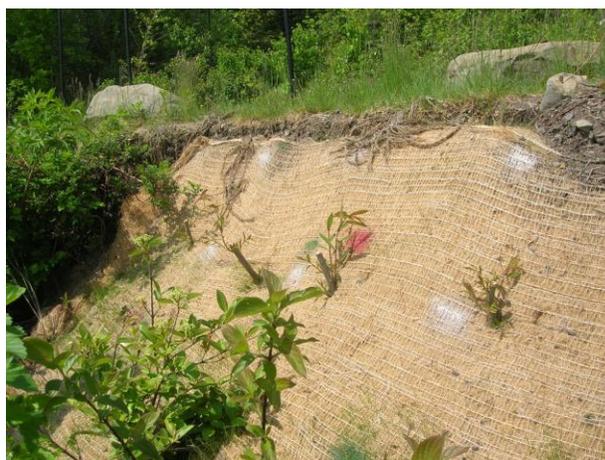
Figure 4: Live stakes and erosion control mats used to repair damage following a storm in April 2007.

Unfortunately, within a year of completing the project, a strong Nor'easter in April 2007 damaged some of the soft shoreline. Because the large storm occurred so shortly after installation, plantings were not yet thoroughly established and were unable to hold the embankment in place. However, the natural bedrock outcrop protected some plants in the northern section of the embankment. About 5/6 of the soft gabion collapsed and slumped downward. As a result, the slumping fabric created a gentler shoreline incline. Scenic Hudson restored the damaged area and replaced the fabric. Rather than bringing in a crew to reset the initial slope of the shoreline, the repair was accomplished by draping the erosion control fabric over the soil and using live stakes<sup>1</sup> to secure it. The original soft gabion featured 14 different plant species for variety. All were planted as fully developed plants. Few of these plants were lost due to the storm, but

<sup>1</sup> Live stakes are ½" to 3" diameter stakes made from branches of tree species which easily and quickly propagate. Commonly used species are dogwood, viburnum, and willow. The stakes are driven into the embankment where the roots grow and bind the soil to prevent erosion.

they slid down-slope and came to rest on the boulder toe. To achieve fast establishment of new shrubs on the damaged slope, readily available ½" to ¾" dormant cuttings of silky dogwood were used as live stakes after the surface of the slope was first secured with a fully biodegradable coir erosion control mat of the needle-punch type. Fortunately, the other shrub species originally planted have successfully grown through the new gabion since the storm in 2007. In the years following, the vegetation had time to become sufficiently established and sturdy enough to hold the embankment during the tropical storms Irene, Lee, and Hurricane Sandy in 2011 and 2012, see figures below, as well as the usual physical forces of ice, waves, and currents.

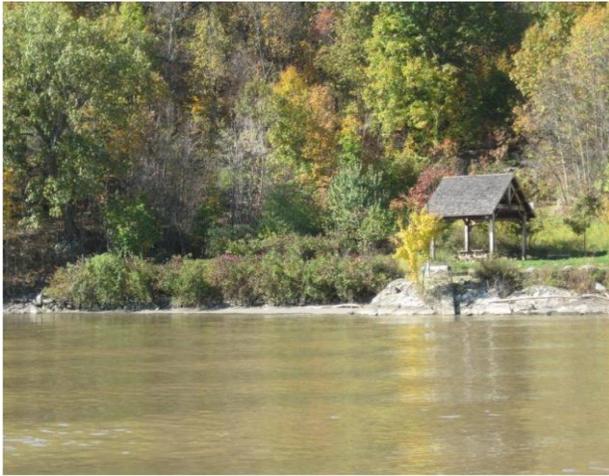
**Figure 5: Well-established embankment and healthy vegetative growth accomplished by spring 2012.**

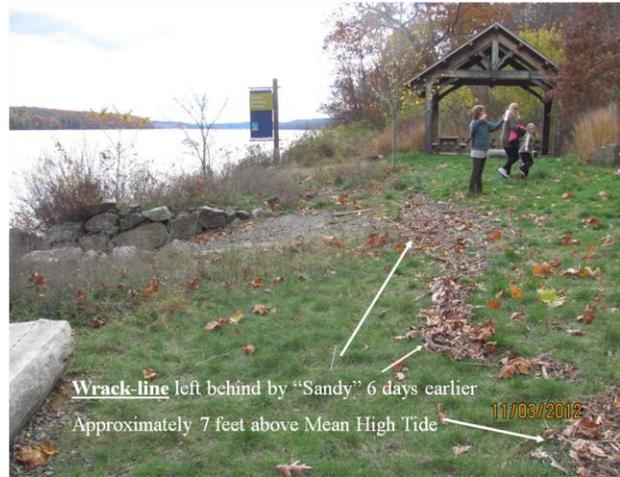
**Figure 6: Despite a wrack line 7 feet above the mean high tide, the shoreline survived Hurricane Sandy with no damage.**
