CASE STUDY: COXSACKIE BOAT LAUNCH

OVERVIEW

Improve eroding shoreline consisting predominately of historical dredge fill in order to protect the nearby parking lot. Demonstrate the functionality of restored natural shoreline features at providing erosion protection and improved habitat, as well as human access.

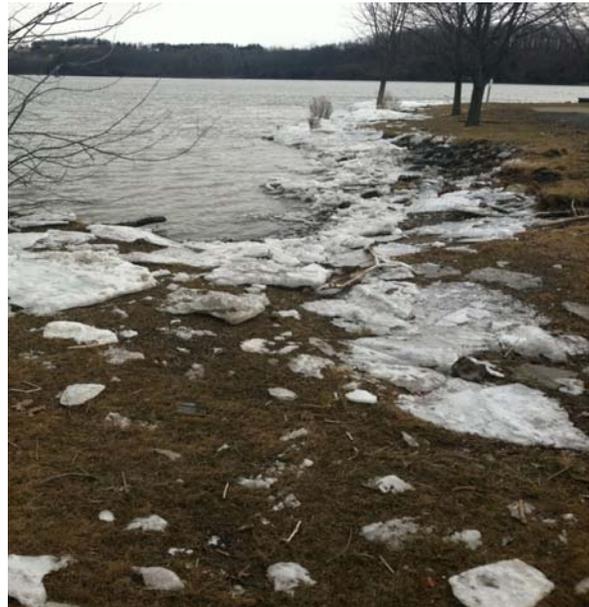
Figure 1: Preconstruction view looking east during winter with ice in shore zone, note erosion on right.

Erosion occurring along the natural shoreline near the sunken historical boat began encroaching on the parking lot. Village officials and OPRHP sought simple solutions to mitigating erosion and damage to the boat launch site, while maintaining human access to the shore.

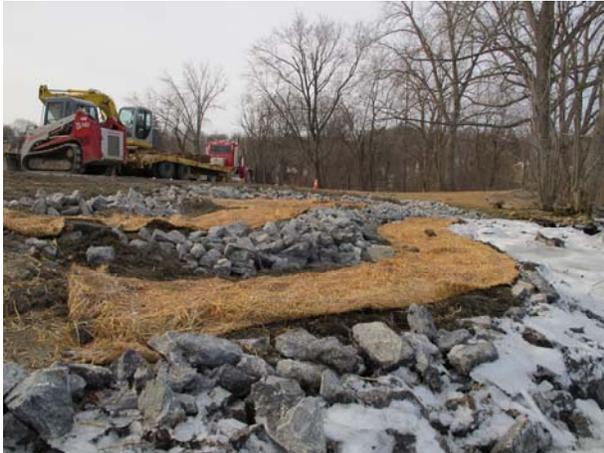
Figure 2: The site following construction in February 2012.

The design called for re-grading the shore zone to a shallow slope (less than 18 degrees) with clean fill, creating three terraces of medium sized stone for native re-vegetation, and placement of boulders in the intertidal as a partial sill to limit wave and ice erosion. Retaining the shallow slope and natural ecological features also retained the ability of park patrons to access the river.

The shoreline restoration activities began on February 6 and 7, 2012 with the re-grading of the site with clean fill. Working at low tide and using a floating silt curtain, and careful machine work, the contractor placed rock fill in the intertidal and upland areas. Three terraces using medium sized were created. Medium sized stone was also used to stabilize the area around a nearby outfall pipe. Large boulders were placed in the intertidal to create a partial sill to increase erosion protection. The terraces were planted with two species of bulrush, pickerelweed, dogwood and buttonbush. Sycamore trees were planted in the upland adjacent to the parking lot.

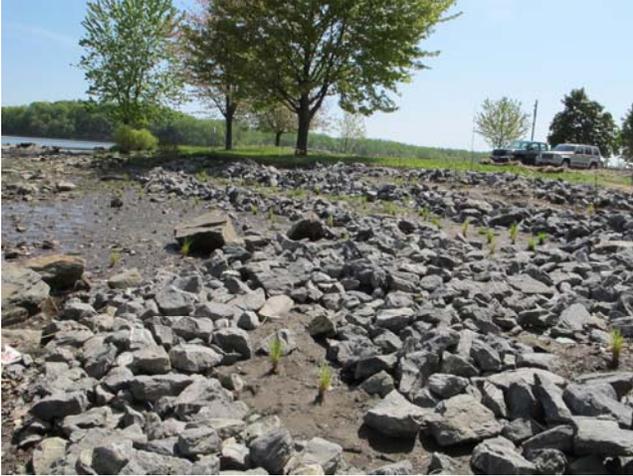
Figure 3: The site immediately after planting, note the small plants between rock terraces.

The native planting took place in early May during spring growing season to maximize potential for stability and growth. Students from Cocksackie-Athens High School helped plant approximately 200 plugs and saplings on May 7, they also participated in various other educational activities.

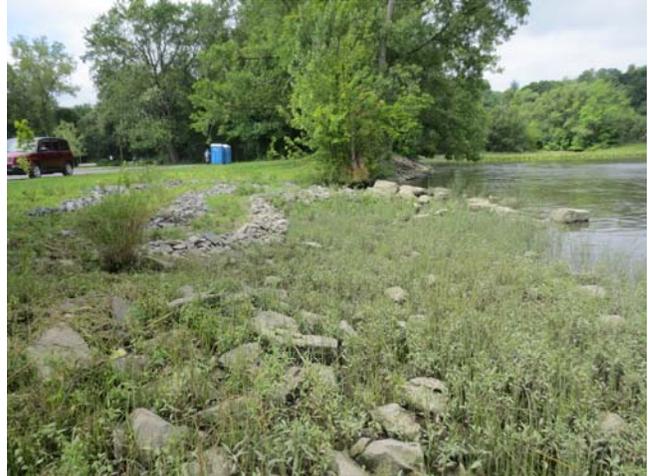
Figure 4: The site after approximately three months of growth.

As of July 2012, monitoring of the shoreline restoration indicated that the gradual slope, rock and plant stabilization improved the erosion issues threatening the parking lot. Very few plantings experienced die-off in the immediate months following the restoration project. The pickerelweed and bulrush showed significant growth as seen in Figure 4. Retaining and enhancing the natural appeal of this shoreline reach has provided diversity in shoreline within this park, and has allowed continued human access with the shore zone.
